SEISMIC HAZARD EVALUATION

1230 12TH STREET
MODESTO, CALIFORNIA

FINAL REPORT
May 2006

COMPLERE ENGINEERING GROUP, INC.
JOB NO. 25090

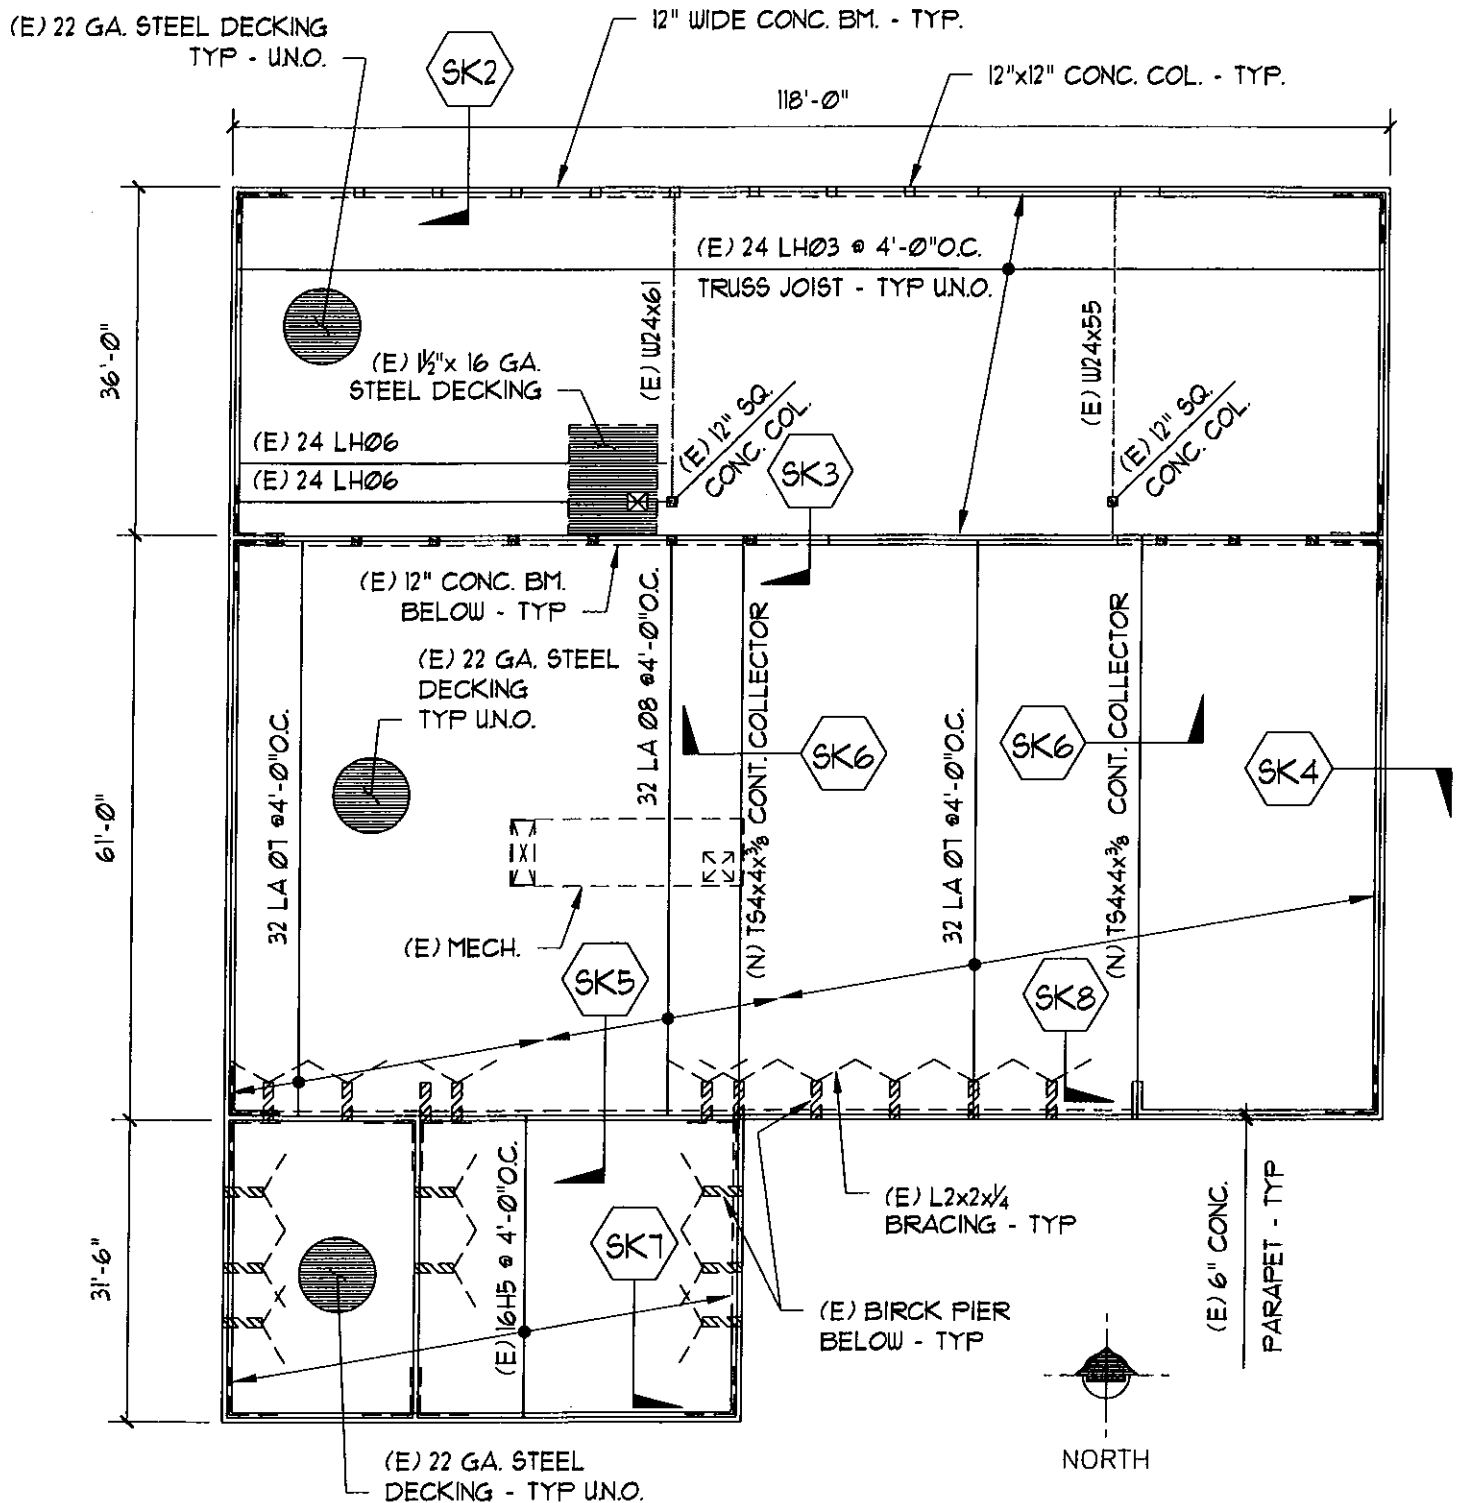
FIGURE 3

From the analysis and evaluation it was found that the roof diaphragm does not meet the requirements of the UBC and requires additional strengthening. It was also found that all of the existing masonry walls in the subject Building have sufficient strength to resist the required lateral loads due to earthquake. Furthermore, the connection of the roof diaphragm to the reinforced masonry walls has sufficient strength to resist wall out-of-plane forces at the top as prescribed by the UBC.

The subject Building in Modesto is generally in very good condition and shows a high quality of workmanship. The reinforced brick walls and attachment of the roof diaphragm to the walls are adequate to resist lateral forces due to earthquake as recommended in the provisions of the UBC. However, the metal deck roof diaphragm is inadequate to transfer shear to the shear walls in the north-south direction. This may be remedied by supplying a steel collector, at two locations - down the center of the structure aligning with the entrance wall, and near the East exterior wall aligning with the first interior 4ft wing wall. The deck shall be welded to these new collectors and connecting one end of the center collector to the concrete "cap beam" above the entrance of the building, and one end of the "East" collector to the concrete "wing wall". This is shown in Figures 3, SK7 and SK8. This mitigation would then transfer shear from the roof diaphragm to the two (2) exterior walls and two (2) new interior shearwalls, one at the "front" wall near the entrance, and the other at the 4ft "wing wall", 25ft from the East exterior wall. These two upgrades will bring the building up to life-safe performance according to 1997 UCBC guidelines. Since this work involves the removal and replacement of two strips of existing roofing, it would be ideal that the construction could be performed at the time the building is re-roofed, if this is planned in the near future.

As part of the above mitigation, it may be prudent to perform a more comprehensive inspection to verify attachment to truss joists and secondary bracing systems to the main structure, while the roof system is exposed.

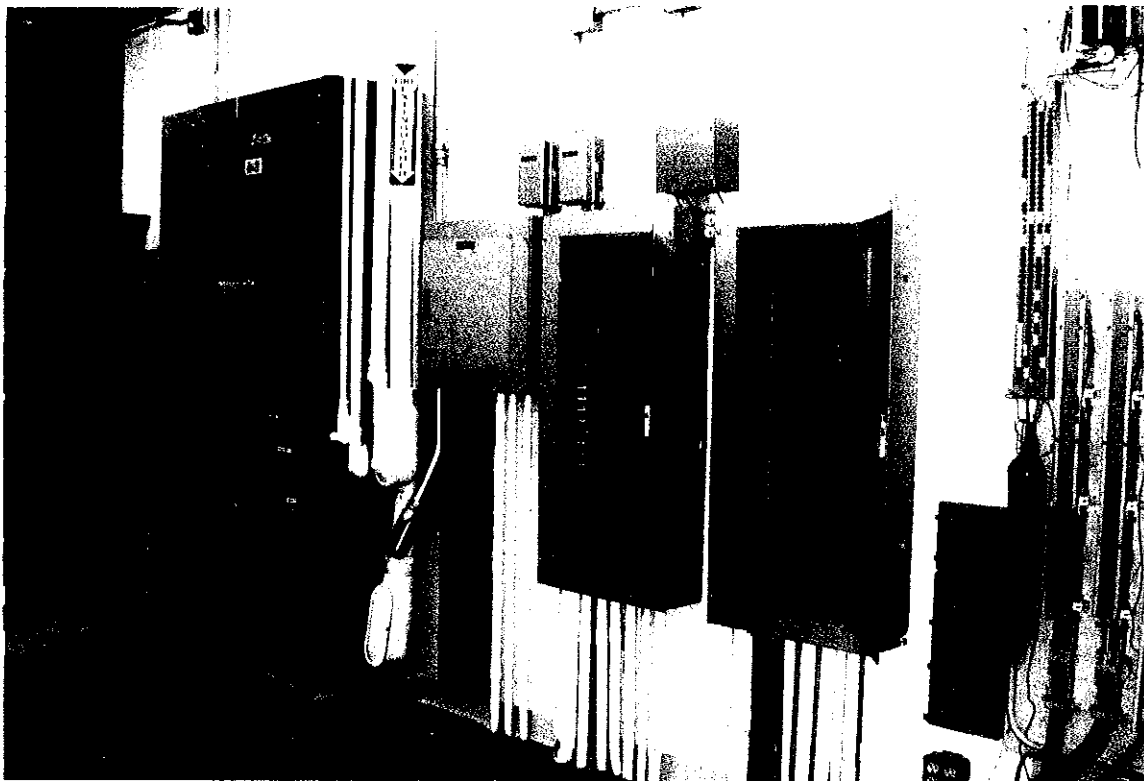
PHOTO NS-6 - ELECTRICAL PANELS

The only substantial mechanical equipment in the building is the roof mounted HVAC units and domestic water heater. No substantial piping was observed above the ceiling system, although there was HVAC ducting present in the ceiling space which was un-braced. A photograph of a representative roof mounted HVAC unit is shown in Photo NS-5. The roof mounted HVAC units and the Electrical Panels appear to be well anchored and do not require mitigation. A photograph of the

Electrical Panels is shown in Photo NS-6. The water heater in the janitorial closet lacks adequate positive anchorage to the structure. In order to prevent damage to the water heater, it is recommended that the top of the tank be more adequately attached to the structure and measures taken to reduce sliding at the base.
